Manhole Inspection Summary

Manhole # S69M__012MH

Insp Date: 1/31/08 1:22 PM

Location Address: **1100 Steelton Ave.**

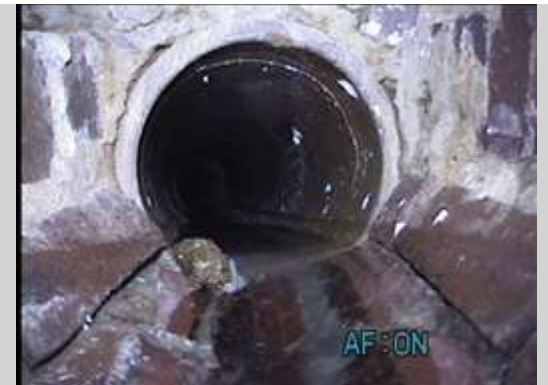
3 O'Clock Inflow

8 in. Circular Gravity Sewer
Pipe In @ 3 O'Clock

Pipe Height: **8.4** (in.) Rod and Bar (Angled)
Pipe Material: **Clay** ☐ Pipe Lined
Invert Depth: **7.42** (ft.) Flow Characteristics: **Fast**
Deposits: ☒ None ☐ Mud ☐ Sludge ☐ Debris ☐ Grease
Silt Depth: (in.) Deposits Extent:
Infiltration: **None** Pipe Seal Cond: **Sound**

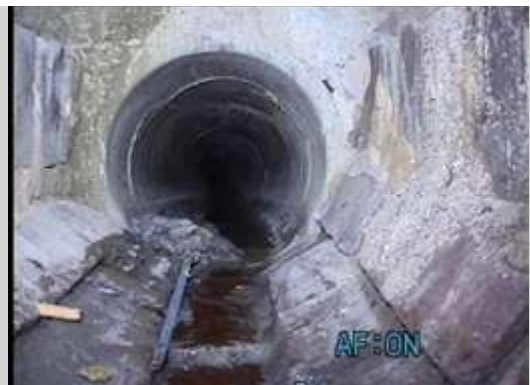
6 O'Clock Inflow

8 in. Circular Gravity Sewer
Pipe In @ 6 O'Clock

Pipe Height: **8.4** (in.) Rod and Bar (Angled)

Pipe Material: **Clay** ☐ Pipe Lined

Infiltration: **None** Pipe Seal Cond: **Sound**
